SubDrive Utility™ Firmware Release Notes

Consult the SubDrive Utility™ Owner's Manual for instructions on how to update drive firmware via USB storage device.

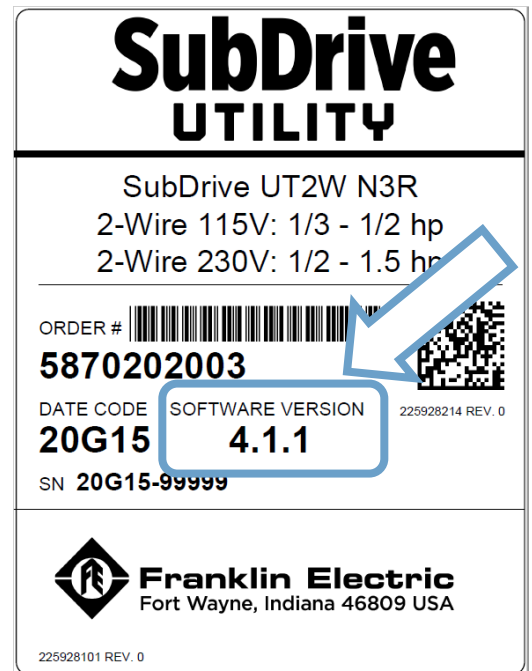
Shipping Carton Label

The firmware version of the drive can be found on the shipping carton label as shown in the example to the right.
